# ENGINEERING CHANGE NOTICE

## BEARHAWK LSA PLANS

### DRAWING #5

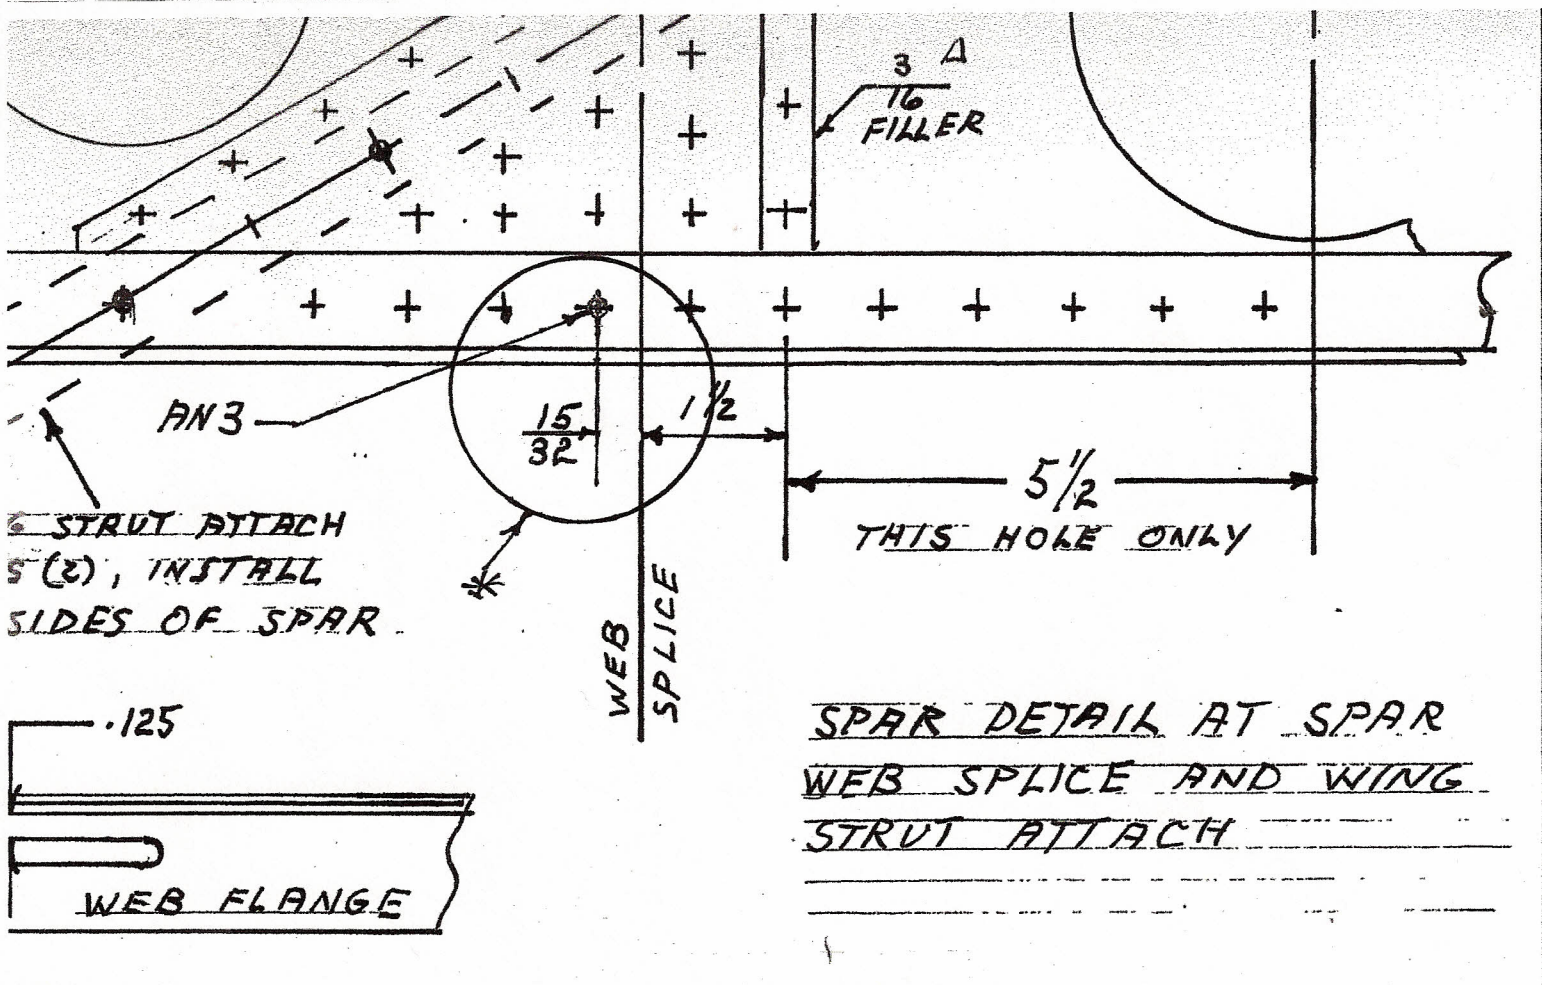
The AN 3 hole to mount the pulley bracket to the spar lower cap strip was dimensioned wrong @  $1\frac{1}{2}$ " from web splice  $\phi$ . Position should be  $\frac{15}{32}$ . Call me if you have already drilled your spar caps. 540-473-3661
